ACTUAL STATE OF DRAINAGE SYSTEM ON THE EXPERIMENTAL
FIELD "RADMILOVAC" AND PRIORITY WORKS TO BE DONE FOR THE
IMPROVEMENT OF ITS WORKING CHARACTERISTICS

Nevenka Djurović¹ and Ružica Stričević¹

Key words: drainage system, recipient, drainage functioning, water table depth.

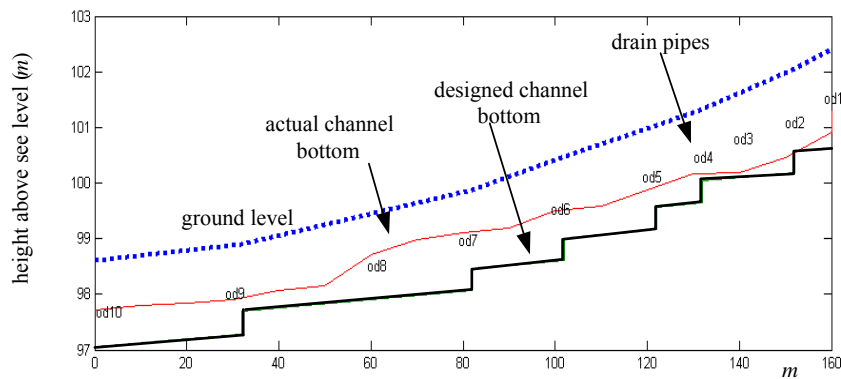
According to the thorough review of drainage field in January 2004, it can be concluded that functioning of drainage system was significantly reduced. The measurement of canal depth refers to the conclusion that silting of the canal bottom was appreciable reducing the cross-section of water flow, especially in the lowest part of the drainage field (Fig. 6). In some canal reaches water level was near the soil surface as well as ground water table (Photo 1, 2). Besides silting, the major reasons for ruining the canals and changing of hydraulic characteristics were solid waste disposal by malpractice of people and absence of weed control, whereby luxinate growth of emersive annual weeds and perennial

bushes and trees was enabled. Nine of 10 drain outlets are below the bottom of the canal. These are the main causes of drainage system malfunctioning (Fig. 6).

Fig. 6.- Longitudinal section of the Radmilovac canal (designed and actual bottom)

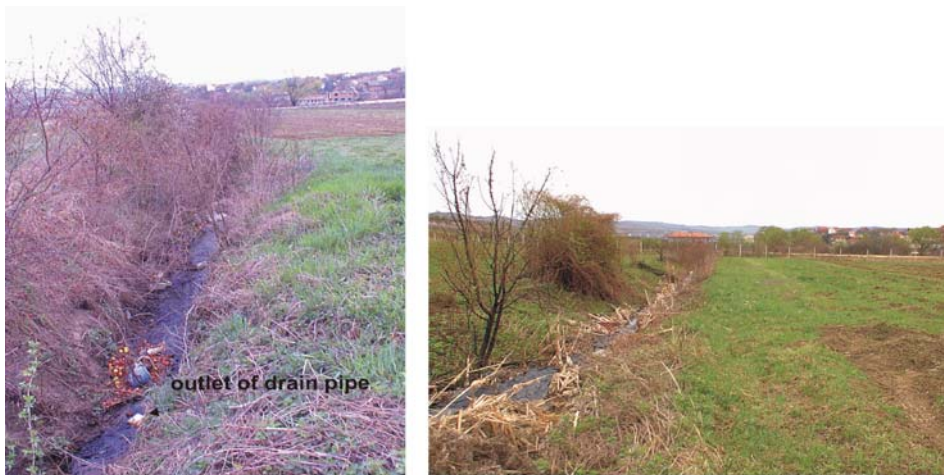
Photos 1 and 2 - Actual state of Radmilovac canal

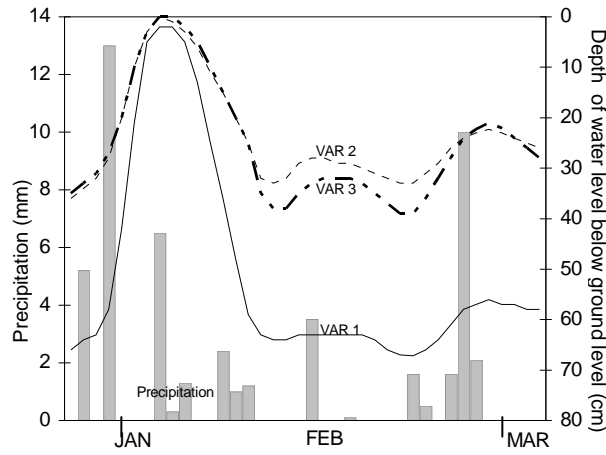
The obtained data by measuring ground water table depth over the three drainage treatments in the period January – March show that water table depth was very shallow. It means that ground water above drains was very high, varying from 0.6 – 0.9 m (Fig. 7).

Fig. 7.- Precipitation and water table depth from the soil surface (January- March 2004)

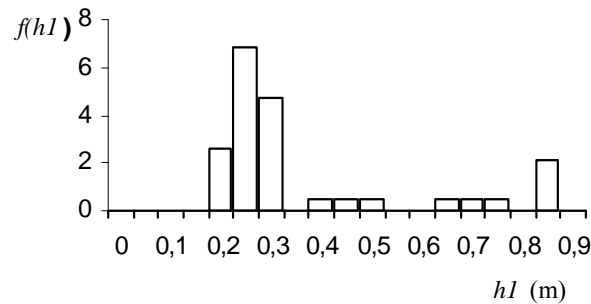
The histogram of ground water height in the period Januar-March 2004 (Fig. 8 – 10) shows the movement of the total measuring scope toward higher values. It is less marked in the drainage treatment I, with narrower drain spacing. It can be explained by the fact that the only drain, whose outlet is above the canal bottom belongs to that treatment (Fig. 6). In the drainage treatment II and III mean value of measured ground water height is moved from 0.458 m to 0.6634 m and from 0.473 m to 0.6485 m, respectively. In the period just after the construction, when the drainage system functioning was well, the histogram was expanded with measured values of data from 0 – 0.9 m, whereas in the period January-March 2004 measured data are grouped around the value of mod and mean value. A small dispersion of data refers to a small value of variance and standard variation of 0.207 m, 0.096 m and 0.117 m, on the drainage treatments I, II and III, respectively. It can be considered as one indicator more of drainage system malfunctioning.

Fig. 8.- Histogram of ground water height above the drain axes on the drainage treatment I (January-March 2004)

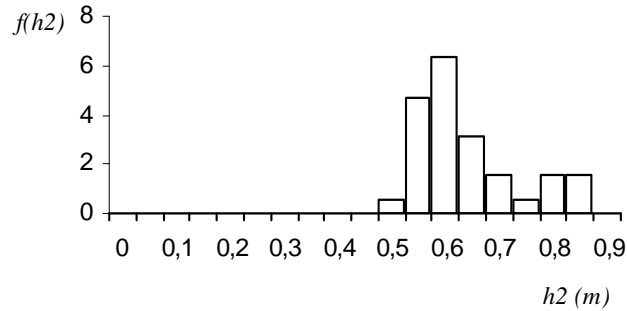
Fig. 9.- Histogram of ground water height above the drain axes on the drainage treatment II (January-March 2004)

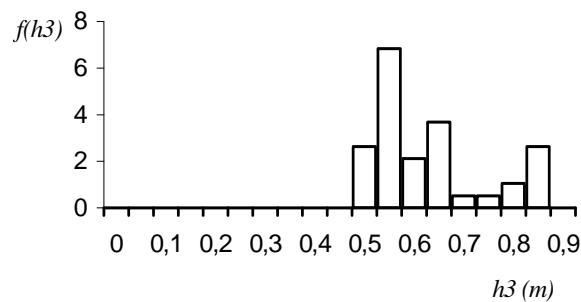
Fig. 10.- Histogram of ground water height above the drain axes on the drainage treatment III (January-March 2004)
