## DRAINAGE SYSTEM MAINTENANCE PROBLEMS IN THE MELIORATION REGION OF VDP "JUŽNI BANAT"

**Abstract:** The aim of this paper is a case study of a melioration region, which will show the state of the channel network, as well as the scope of the implemented maintenance measures, which resulted in the reduced functionality of the drainage system.

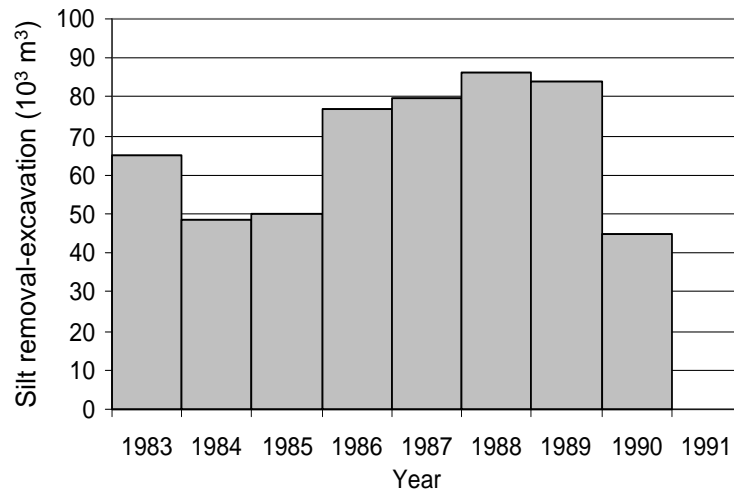
Note: Ratio of the required works  $227.500 \text{ m}^3$  annually

Fig. 1.- The works of silt removal-excitation ( $10^3 \text{ m}^3$ ) performed in the period 1983-1991

The data presented in the Figures point to an impermissibly low volume of works on the maintenance of the erected drainage system. Namely, for the systems to be in function, according to the criteria of their maintenance, the

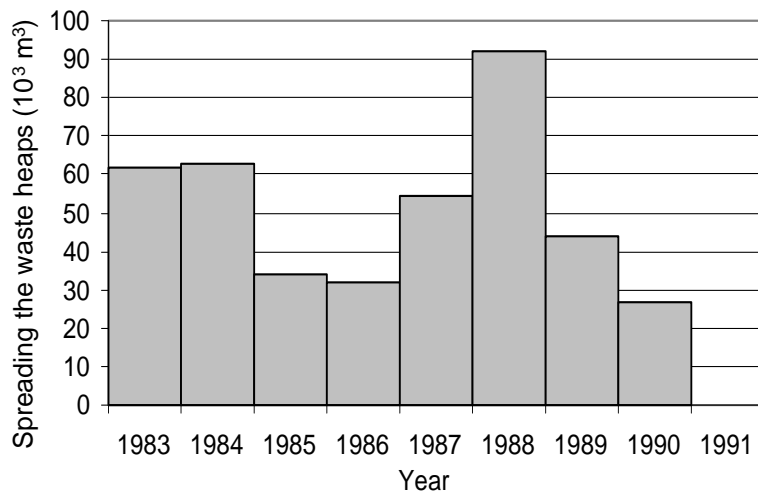
Fig. 2.- The works of spreading the waste heaps ( $10^3 \text{ m}^3$ ) performed in the period 1983-1991

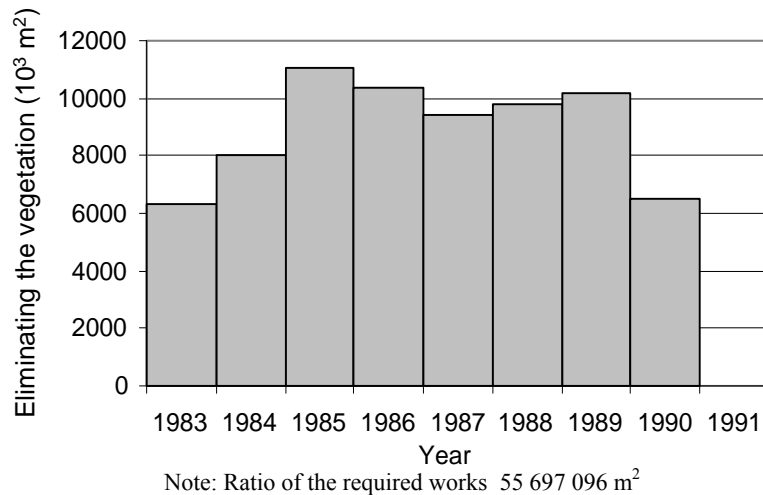
Fig. 3.- The works of eliminating the vegetation ( $10^3 \text{ m}^2$ ) performed in the period 1983-1981
