ACTUAL STATE OF DRAINAGE SYSTEM ON THE EXPERIMENTAL
FIELD "RADMILOVAC" AND PRIORITY WORKS TO BE DONE FOR THE
IMPROVEMENT OF ITS WORKING CHARACTERISTICS

Nevenka Djurović¹ and Ružica Stričević¹

Key words: drainage system, recipient, drainage functioning, water table depth.

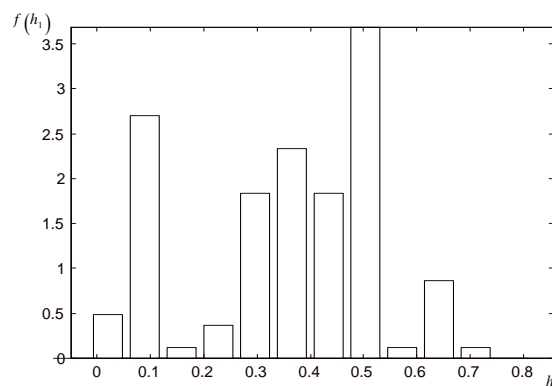
The figures 1 – 3 show that ground water height above the drains was in the range from 0 – 0.8 m with the highest frequency of occurrence at 0.5 m. In the drainage treatment III with the widest drain spacing, more frequent higher values are noticeable (0.7m, 0.8m). Fig. 4 shows the dependence between the height of ground water level (h) and drain discharge (q) in the drainage treatment I during three consecutive cold seasons (November-March) from 1995 – 1997. Besides the scattered points obtained by measuring assumed polynomial trendline of second order, is shown whose coefficients are obtained by the method of least square.

Fig. 1.- Histogram of ground water height above drain on the drainage treatment I
Note: h_i -ground water height above the drain axis on the drainage treatment I;
 $f(h_i)$ -function of density probability occurrence h_i ;

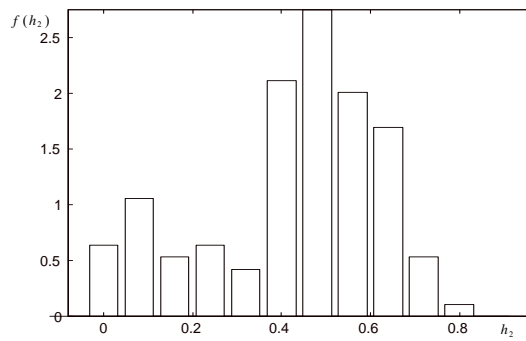
Fig. 2.- Histogram of ground water height above drain on the drainage treatment II
 Note: h_2 - ground water height above the drain axis on the drainage treatment II;
 $f(h_2)$ - function of density probability occurrence h_2 ;

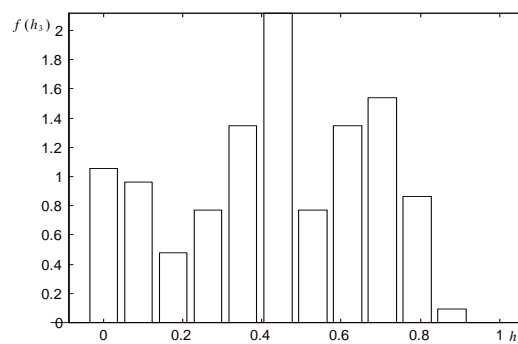
Fig. 3.- Histogram of ground water height above drain on the drainage treatment III
 Note: h_3 - ground water height above the drain axis on the drainage treatment III;
 $f(h_3)$ - function of density probability occurrence h_3 ;

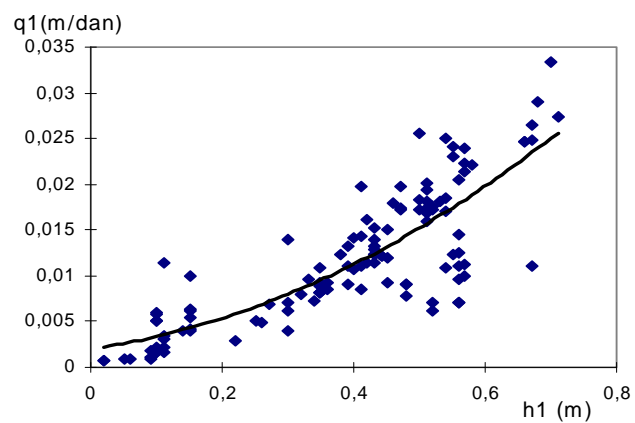
Fig. 4.- h-q curve of the drainage treatment I

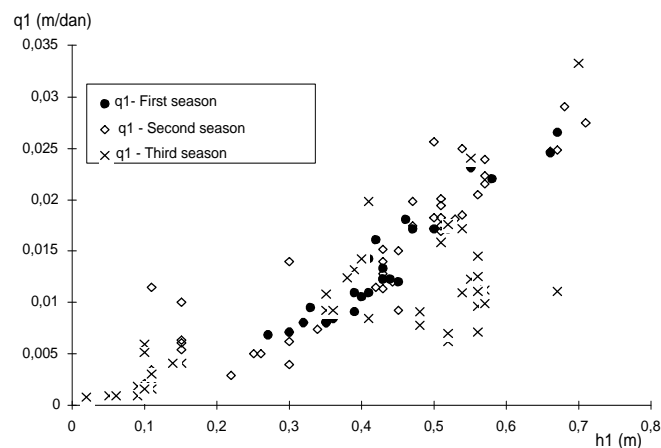
From the series of measurements h and q , three subseries were separated. Each subseries represents one cold season. The aim of this analysis was to distinguish whether differences among the data of the cold seasons exist or not as well as to find out data grouping occurrence (Fig. 5). However, data for all three seasons were occurring in the wide range (0 - 0.8 m) with irregular trend. The assumption of moved statistics (mean value, median and mod) during consecutive seasons is not acceptable. On the other side, it can be concluded that in the first 3 years of drainage system functioning there were not significant differences in interacting relations on the parameters which characterize the functioning of drainage system. It means that drainage process was steady. Such results provided the possibility of being compared with the data obtained after 11 years, when monthly sums of precipitation were in the range of perennial average.

Fig. 5.- Dependence of q i h in three consecutive cold seasons in the drainage treatment I
